ROSEMARY QUARRY  
MUP P-87-021RPL  
ROCK FALL REPORT  
Jan-Mar 2010

Subject: Update Geologic Observations: February, 2010  
On-Going Rock Slope Excavation  
Rosemary's Mountain Quarry  
San Diego County, California  
URS Project No. 27661001.10000

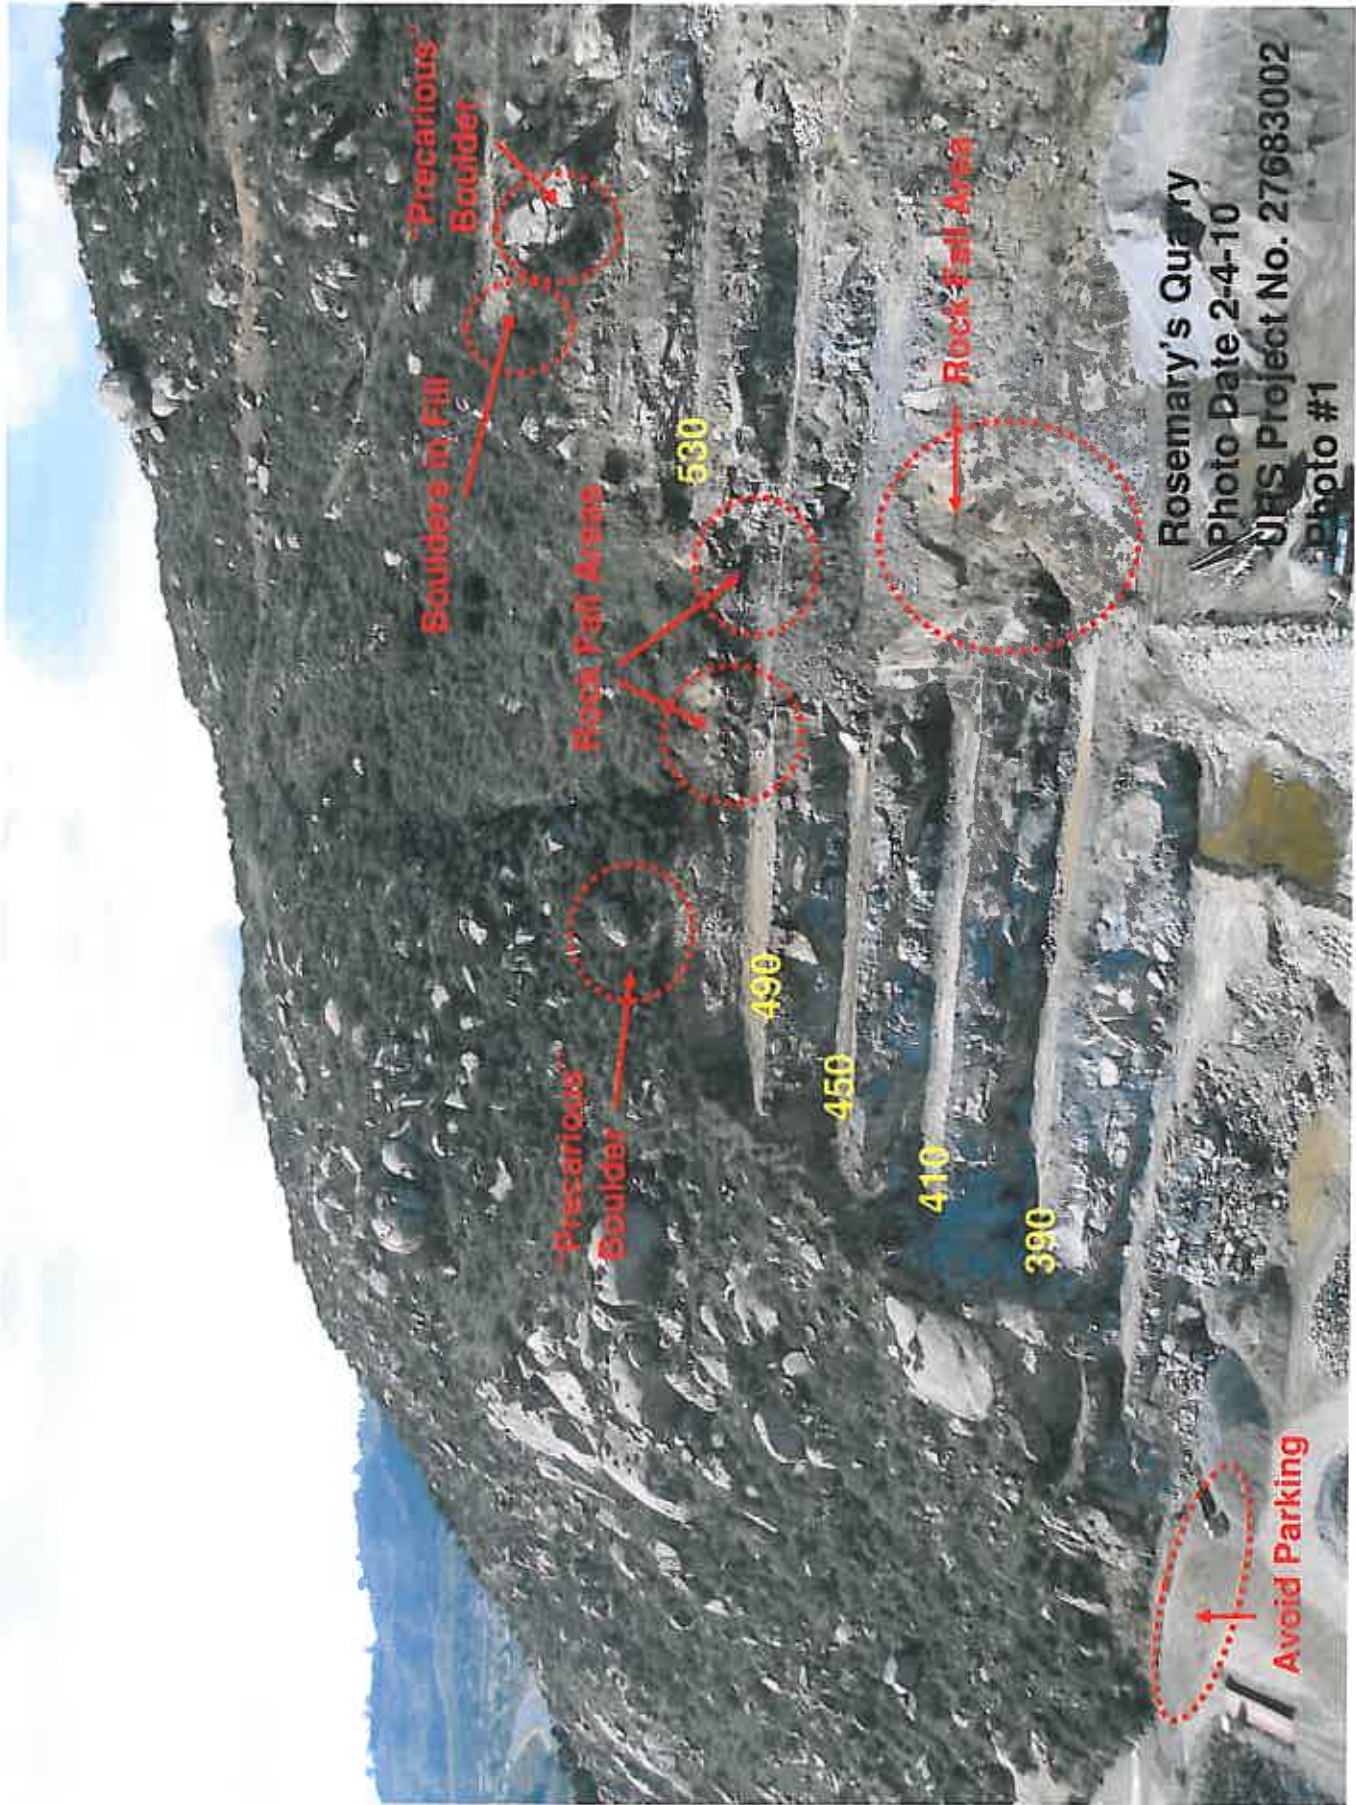
Photo #1

Many small, single block rock falls had occurred as a result of the rain. Recent scarps resulting from block falls were observed above the 610, 570 and 530 benches. Two rock falls each involving about 5 yards of material had occurred along the high wall above the 490 bench. The rock fall areas involved some soil slippage from along the top edge of the cut. One of the previously identified 'precarious boulders' had fallen to the 490 bench.

Precarious Boulder

Boulders in Fill

Rock Fall Areas

Rock Fall Area

Avoid Parking

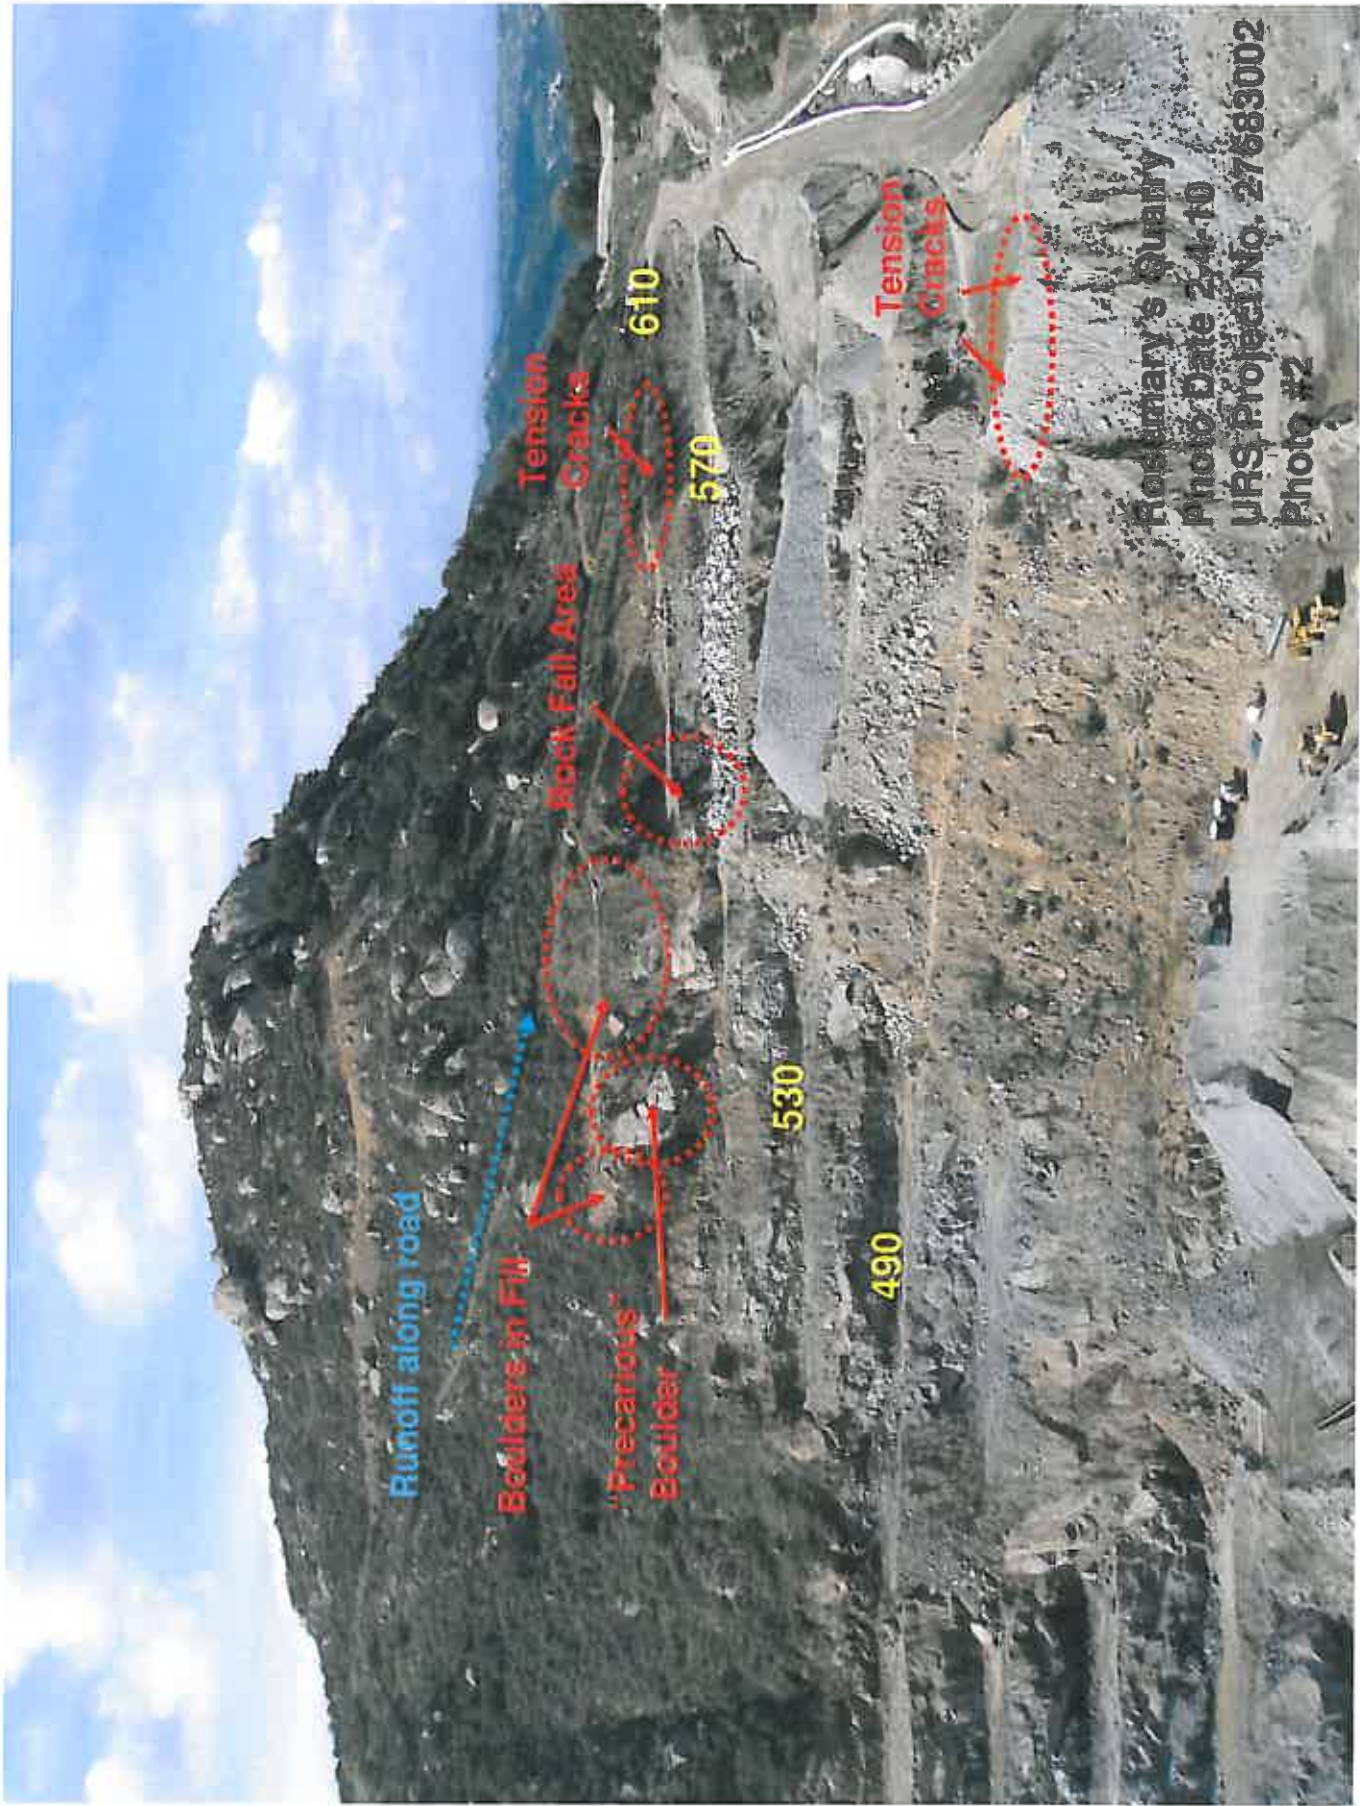
Rossmore's Quarry  
Photo Date 2-4-10  
URS Project No. 27683002  
Photo #2

Tension cracks were observed along the top edges of fill slopes between the 570 /610 benches, and the outer edge of the 490 bench. The cracking appeared to be related to settlement resulting from saturation of the rocky fill material. The outer edges of the fill slope along the dirt access road (above the quarry) contain boulders within the fill. The soil embedding the boulders eroded during the recent rains, such that the boulders could topple with additional rain.

Runoff along road

Boulders in Fill

"Precarious" Boulder

Rock Fall Area

Tension Cracks

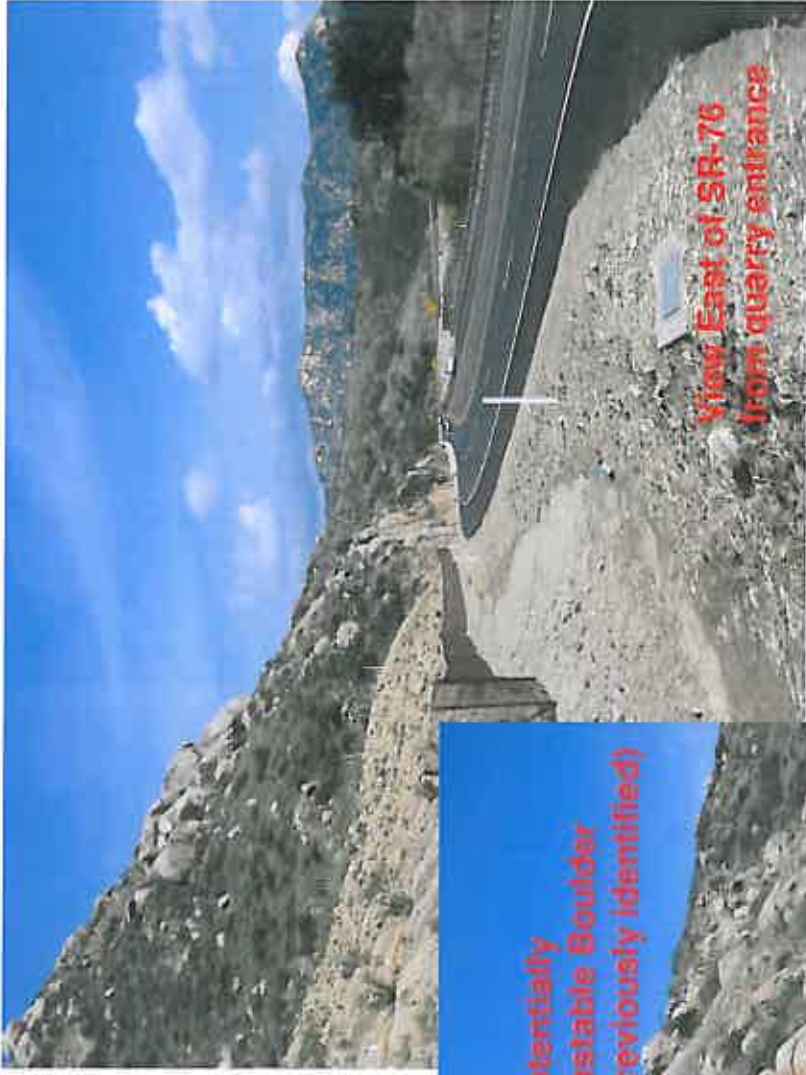
We did not observe slope conditions that were conducive to rock falls. Some of the potential rock falls areas identified previously appeared to be intact. Locally, loose boulders are present on inclined rock surfaces. Rock falls and/or boulder instability, if they occur will likely be contained by the new rock fall protection measures.

View East of SR-76  
from quarry entrance

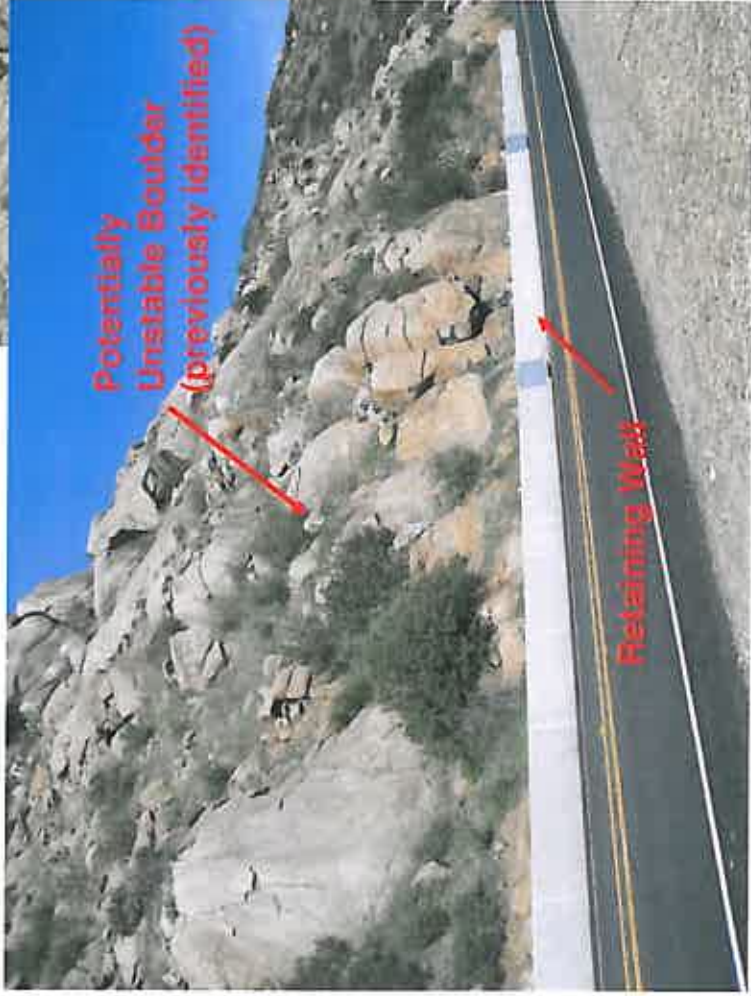
Rosemary's Quarry  
Photo Date 2-4-10  
URS Project No. 27683002  
Photo #4

Potentially  
Unstable Boulder  
(previously identified)
