ROSEMARY QUARRY
MUP P-87-021RPL
ROCK FALL REPORT
July-Sept 2010

Subject: GEOLOGIC OBSERVATIONS
ON-GOING ROCK SLOPE EXCAVATION
ROSEMARY'S MOUNTAIN QUARRY
SAN DIEGO COUNTY, CALIFORNIA

**SCS&T No. 0911167
Report No. 7R**

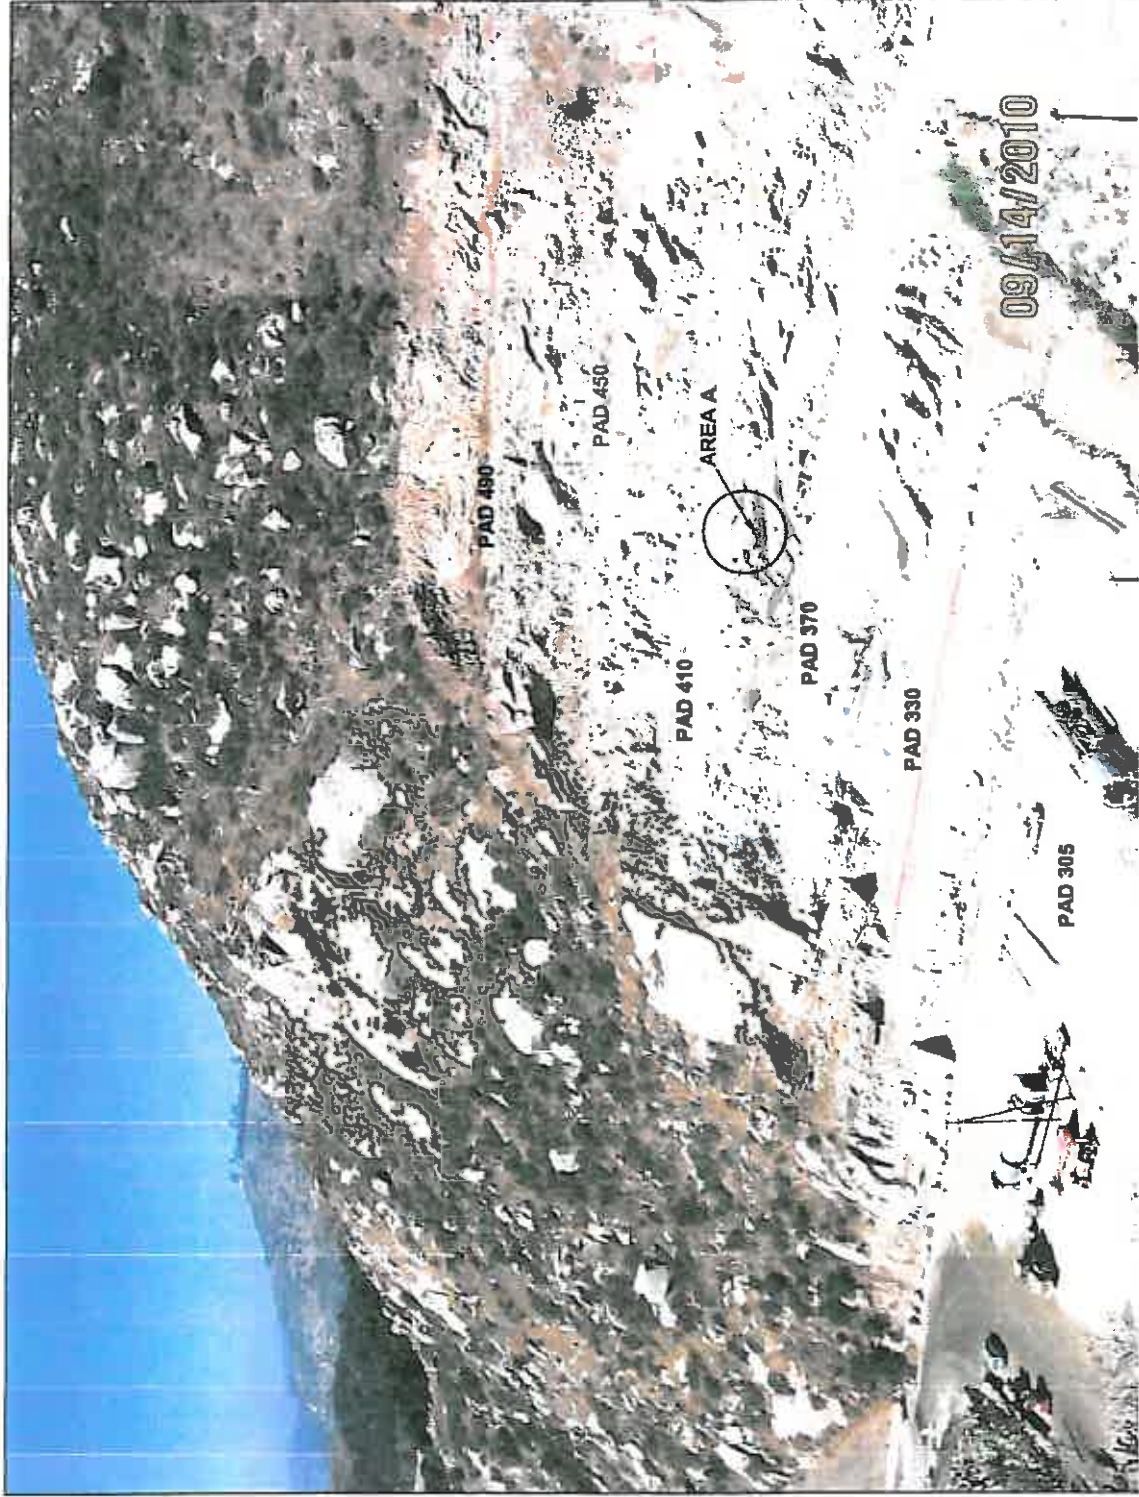
Figure: **1**

A surface reconnaissance was performed of the working floors and highwall slopes within the quarry. Current site conditions appear to have changed since the last visit. Additional scaling of the highwall has been performed. No movement of boulders previously reported as being "precarious" or "within fill" was observed. No new significant rock falls were noted. No significant changes has occurred to the previous small rock fall that was noted in previous

reports. A chain-link fence has been added to the K-rail barrier on the 330 bench and signage was placed adjacent to the small rock fall. Significant groundwater seepage was not observed in the quarry.

In the vicinity of the proposed temporary asphalt plant, the highwalls have been scaled and the benches appear to be suitable for rock fall protection. K-rails have been placed on the 1st bench (Pad 330) above the proposed plant location to facilitate rock fall protection. Adjacent to this site the highwall has been slick sided from the bottom level (Pad 305) to the 1st bench at Pad 330. It is our understanding that fence panels will be placed between the asphalt plant and the highwalls. A portion of the highwall between Pad 370 and 410 is fractured and has some overhangs. This portion of the highwall will be closely monitored for future changes. The area has been labeled AREA A in the photographs included with this report. Although small hanging rocks exists on the highwalls above Pad 330, the benches, K-rails as well as the planned fence panels appear to be adequate for rock fall at the highwall in the vicinity of the proposed asphalt plant.

**HIGHWALL OVERVIEW
ROSEMARY'S MT. QUARRY**
