Subject: Geologic Observation of Quarry Blast  
Field Report from November 20, 2008  
Proposed Rosemary's Mountain Quarry  
San Diego County, California  
URS Project No. 27683002.10170

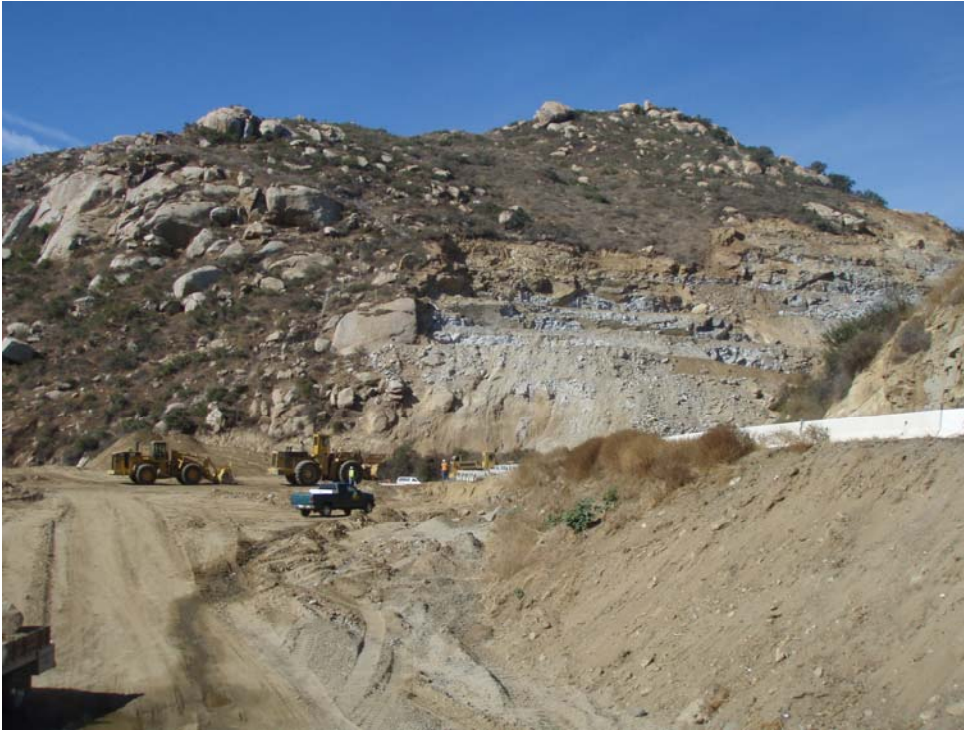
**Photograph 1**

The blast area on November 20 was located along the west side of the quarry near the quarry entrance from Highway SR-76 (see Photos #1 and #2, attached). The blast took place at approximately 11:30am. Boulder instability and/or rockfalls were not observed along nearby portions of Highway SR-76 at the time of the blast. No material fell from adjacent slopes onto the roadway.

**Comments:**  
Blast area is the upper mid-slope bench, near proposed quarry entrance. View is west. Location of highway seismograph is on SR-76 in lower center of photo.

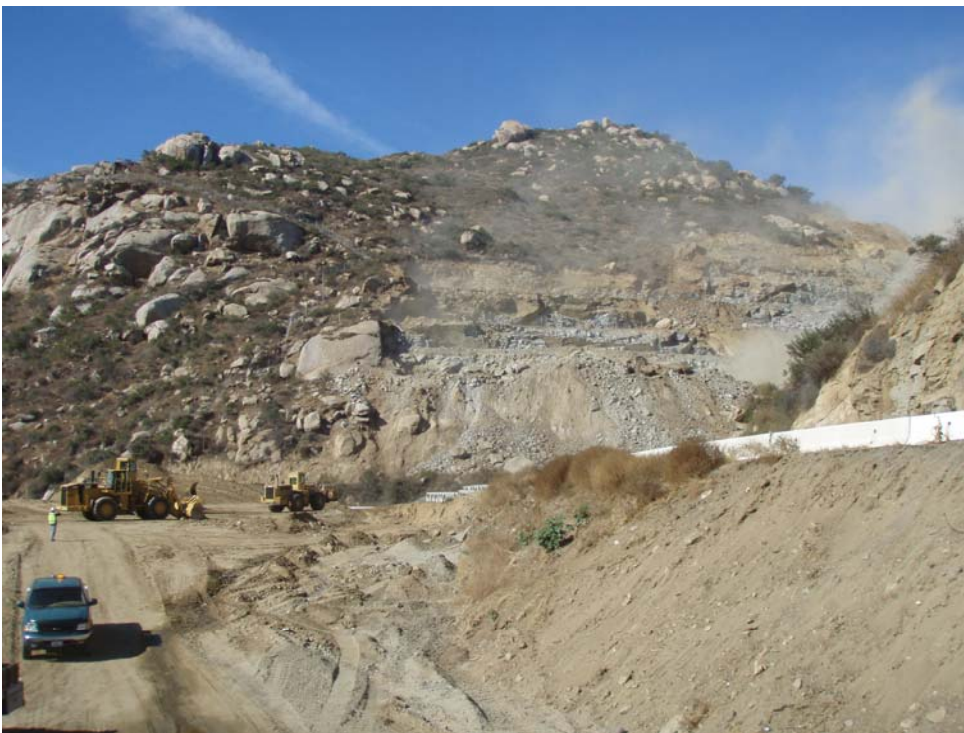
**Photograph 2**

**Comments:** Photo taken shortly after the blast.

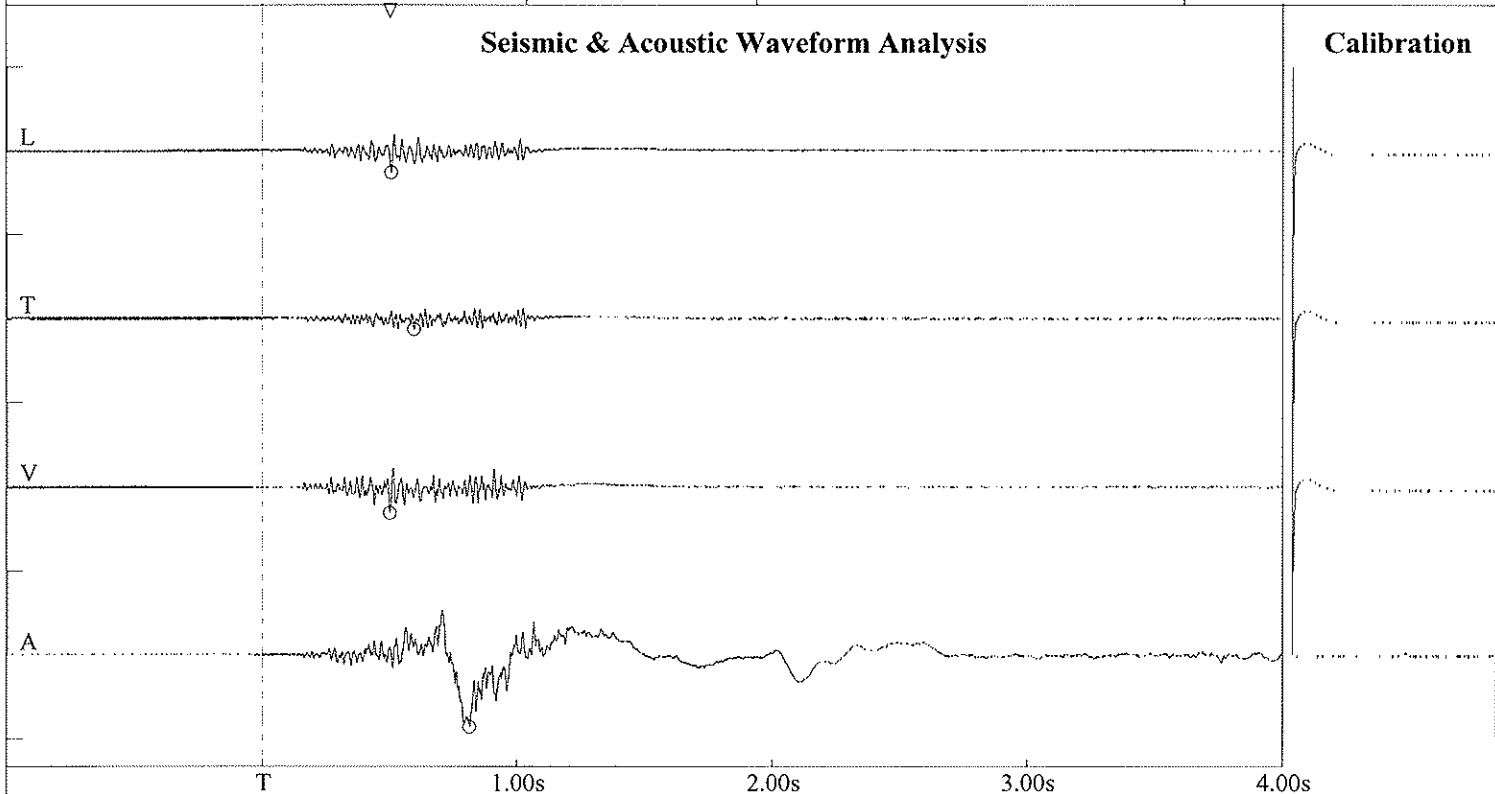
## Seismic & Acoustic Waveform Analysis

Seismograph monitoring was performed by Granite Construction's blasting subcontractor. The seismograph record from the monitoring point along Highway SR-76 is attached. The monitoring point was located on the highway shoulder about 250 feet west of the quarry entrance. The maximum measured peak particle velocity was the vertical component measured at 1.25 inch/second.

Amplitudes & Frequencies	Trigger >>> Peak	Scales & Triggers	Charge / Distance
○ Longitudinal: 1.05 in/s @ 31.7 Hz	504.9 ms	Acoustic Scale: .01843 psi/division	Wgt. per Delay: .0 lb
○ Transverse: 0.53 in/s @ 20.0 Hz	594.7 ms	Seismic Scale: 2.0 in/s/division	Distance: 249.00 ft
○ Vertical: 1.25 in/s @ 38.3 Hz	500.0 ms	Acoustic Trigger: 125 dBL	Scaled Distance: N/A
○ Acoustic: 132 dB / . psi @ 2.1 Hz	814.5 ms	Seismic Trigger: 0.05 in/s	
▽ Vector Sum: 0.71 in/s	501.0 ms
